Project no. 11-53

STATEMENT OF HERITAGE IMPACT

**Proposed
Change of Use and Tenancy Fitout
former Bellevue Hotel,
738 Hunter Street,
NEWCASTLE**

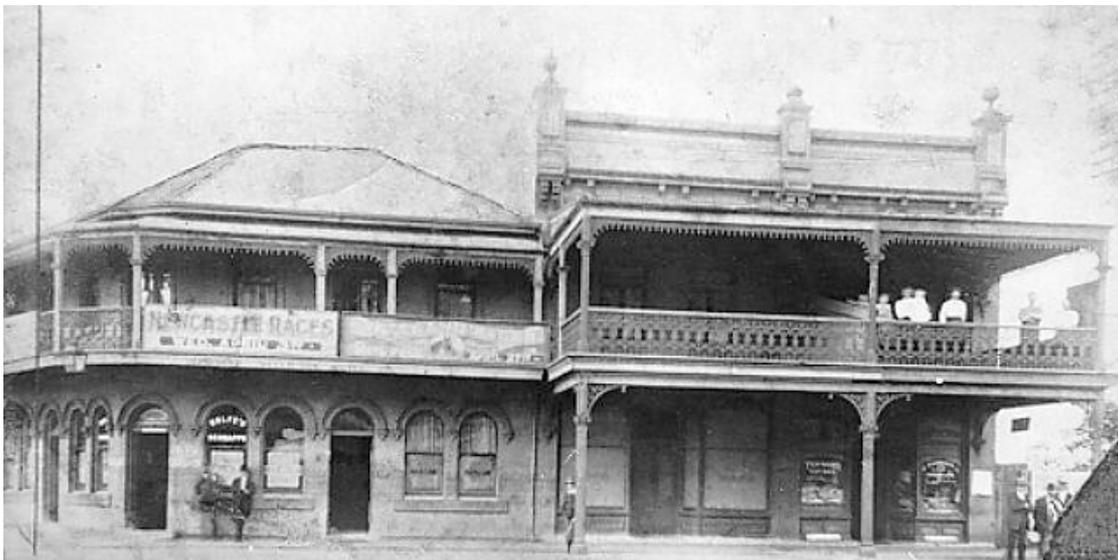
Figure 2: Bellevue Hotel c1905 , showing that the building appeared as two adjoining buildings.
Hunter Photobank No. 163 001425

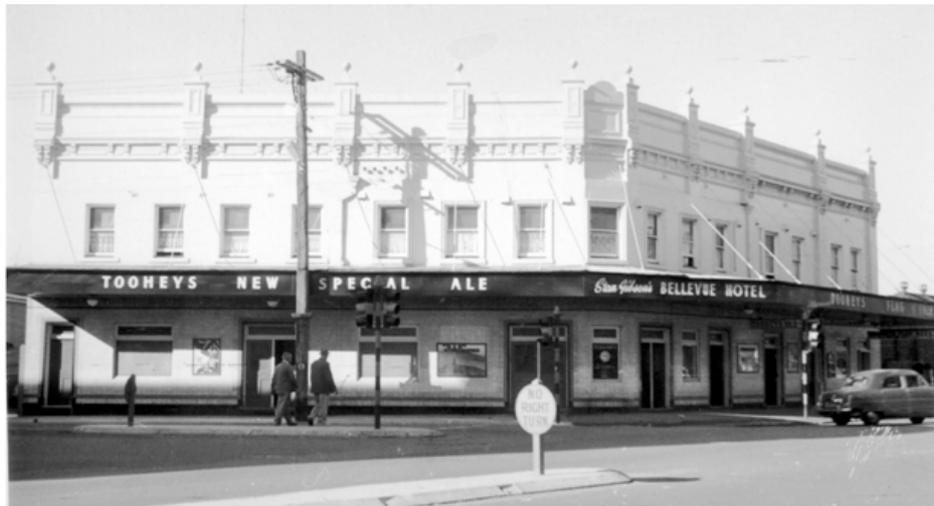
Figure 3: The Bellevue Hotel in 1959.
Hunter Photobank No. 46000023

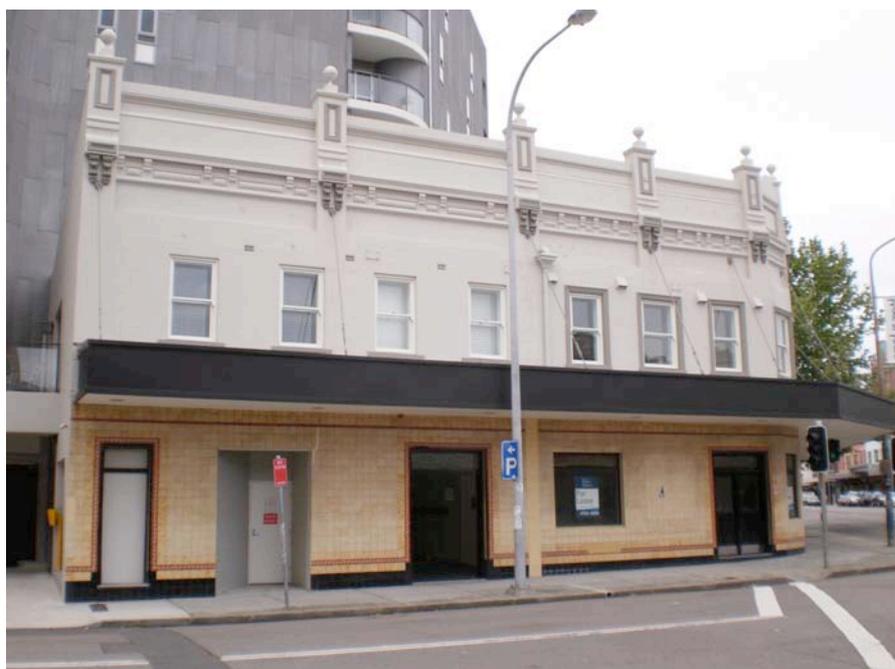
The exterior paint of the building has been stripped and repainted, with the areas below the cantilevered awning remaining substantially intact. This is a significant change from the days when the building was painted in the blue and red of the Newcastle Knights Rugby League team.

Figure 4: The Bellevue Hotel in October 2011
Photo by Stephen Booker

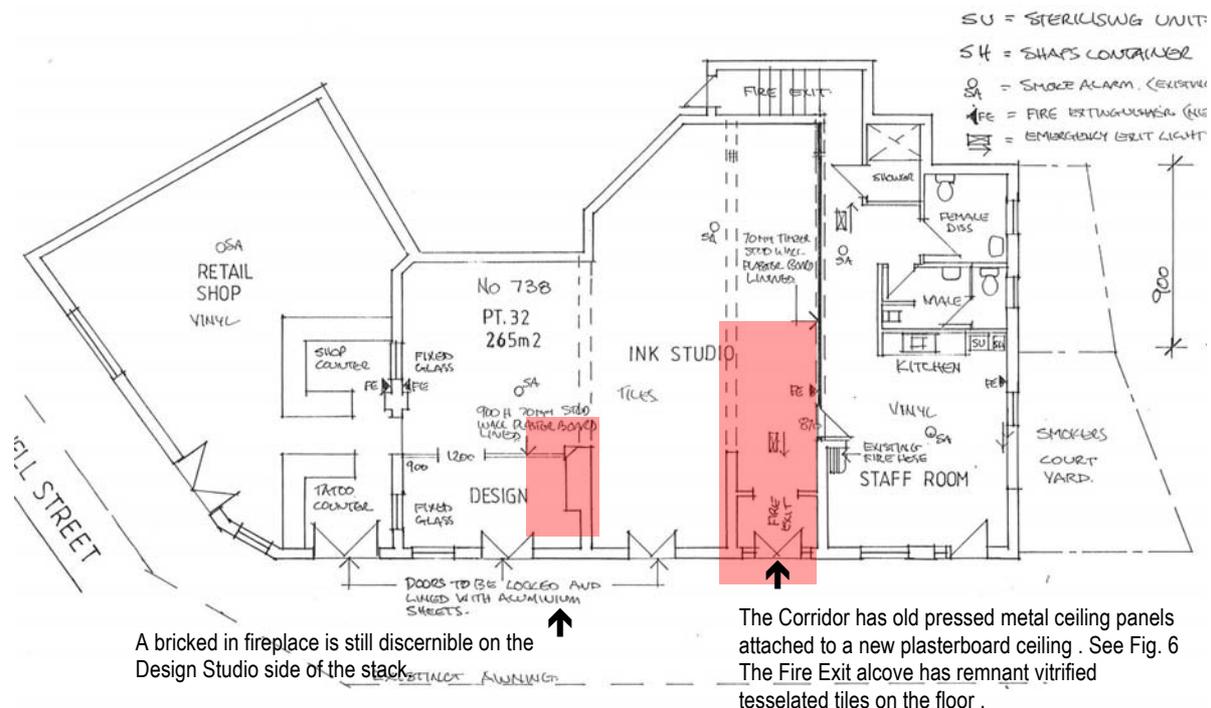
Figure 5: Floor Plan by Just Drafting

The fitout entails construction of a 900mm high partition to the central design area, a full height separation wall between the Kitchen, Staff Room, Toilets and the Ink Studio.

The existing walls are proposed to be set with a lime plaster to a smooth glass like finish. An aluminium dado sheet is to be affixed to the walls to a height of 900mm to protect the wall finish and provide a resilient and hygienic finish. Floors are to be sheet vinyl over the existing concrete and particle board floor, with all salient angles and skirtings covered and welded.

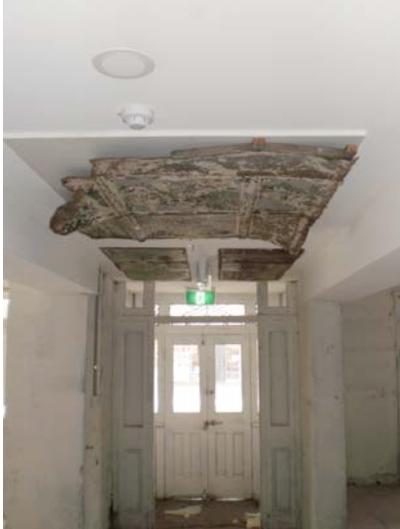
- the remnant pressed metal ceiling lining in the Exit corridor, which is rudely affixed directly under the new plasterboard ceiling (refer to Figure 6),

Figure 6. Sections of pressed metal ceiling and battens affixed to the new plasterboard ceiling.

The purpose of these is undoubtedly, to represent the early ceiling materials present in the Ground floor of the Hotel. Removal of the original ceiling must have been reasonably careless, as the panels are damaged and have jagged edges and are not evenly secured to the battens underlying. It is recommended that the panel be secured where the loose edges appear and the whole either sheeted over with clear perspex or framed and the open edges sealed so that dust can't be dislodged from above the panel. The former will present difficulties through deflection of the perspex sheet and issues with providing sufficient fixing without penetrating the ceiling panels.

The metal ceiling panels are clumsy in the way they have been represented. In the proposed development, this forms a potential source of dust and airborne debris that must be contained. It is for this reason that the two options have been put forward:

1. Remove the panels and reinstate when the business moves out. This is counter productive to the rationale of providing the interpretation panel.
2. The second option is to box or cover in the panels with perspex to enable them to be seen, but prevent them from becoming a dust ledge.

The second option has been canvassed as the most appropriate heritage conscious outcome.

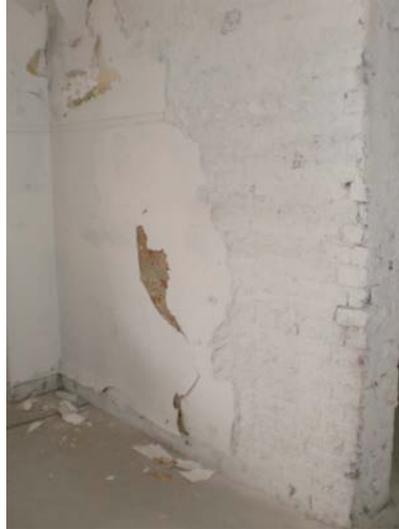
- the raw state in which the internal walls have been left, including peeling paint in the Exit area (Figure 7) and
- the tessellated floor tiles left in the same area (Figure 8).

Figure 7. The raw state in which the walls have been left.

It was explained that the remnant wallpaper and paint on the walls, even though it is peeling off, is historical evidence of early internal finishes in the hotel. It is worthy of retention, because it is *in situ*, and not simply a record prior to demolition. Unfortunately again, it presents a hygiene issue and for the tenancy to *vaibly* proceed, the wall surfaces will need to be consolidated or secured in some way so that smooth impermeable finishes can be achieved. The most reasonable manner of achieving this is to batten the walls so affected and sheet with moisture resistant plasterboard. The underlying finishes will at least be preserved in this instance.

The peeling wallpaper and paint is an important remnant element of the building. It is unknown as to why it was left in the state it was, and not consolidated and protected in the new works that were performed. None the less, it is an unequivocal primary record of the finishes used in the building, and needs to be retained and protected.

The best way to protect this material is to cover it with a supplementary wall so that it will remain relatively undisturbed into the future.

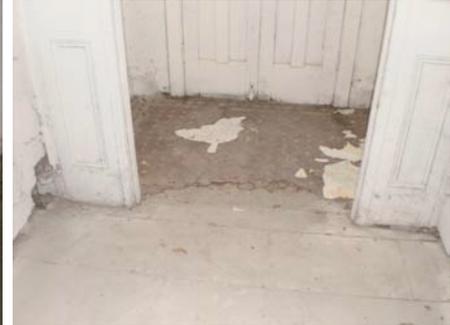
Figure 8. Tessellated vitrified tiles remaining in the Exit alcove.

The tessellated floor tiles shown in Figure 8 are dislodging at the edges, and need to be protected and preserved. As part of the fitout works, the floor needs to be secured in this area, by refixing loose tiles and filling the floor adjacent to the north and terminating between the door jambs, with a mortar infill. New tiling in the Ink Studio can then be laid from that point northwards. We do not recommend the matching of the floor tiles and integrating the old with new tessellated tiles. This would confuse the interpretation of the site, even though it would make for an homogenous floor finish.

Securing the tessellated floor tiles is essential to retain early extant fabric, provide definition between new and old, through the defined infill of missing areas of tiles back to a rational position, in this case the door jambs and installing new tiles beyond that point thus retaining and conserving the existing and differentiating new interventions and materials.

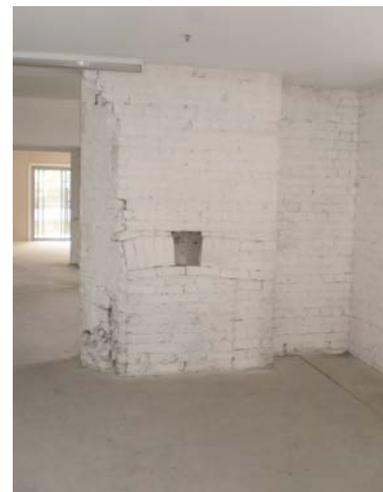
Where the fireplace is located on the Design Studio side (west) of the stack, it shall not be plastered over, but left as is and the aluminium dado sheet fixed over it.

Figure 8 Fireplace hearth is still discernible. This area is to become the Design Studio.

The fireplace hearth is to be protected by the application of an aluminium sheet dado panel as detailed on the fitout drawings.

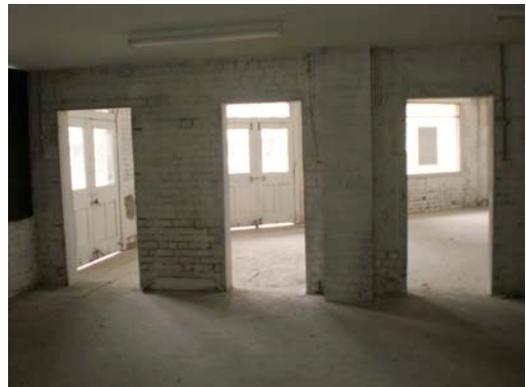
This wall would appear to be a remnant internal wall from the earliest phase of the hotel construction. The fireplace wall is also part of this construction.

There are three openings in this wall. Refer to Figure 9. The central opening is to be retained and the two flanking openings are to be infilled with glass as vision panels to enable supervision of the Retail area.

Figure 9. The central wall in the older section of the building.

Glazing the previous doorways either side of the central opening in the west wall of the Ink Studio retains the openings but provides the surveillance required from the Studio to the Retail space.

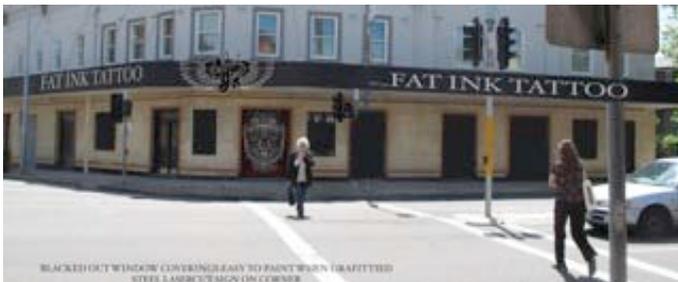
Figure 10: The proposed awning mounted signage

Refer to Figure 10 for the signage and corner icon proposed to be mounted on the cantilevered awning fascia. The lettering style of "FAT INK TATTOO" in Times New Roman extended suits the proportioning of the fascia of the awning and combined with the corner icon, constructed in laser cut metal, will be a balanced and low key signage intervention. There are no illuminated signs proposed.

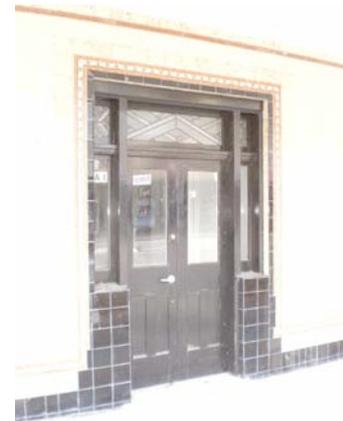
Locking the doors and fixing black powdercoated panels to the exterior will not obscure legibility of the size and proportion of doorways nor glazing allowing full appreciation of the Hotel's form as it stands, whilst protecting the glass and door panels from damage.

Figure 11: Typical doorway.

The proposal to fix a powdercoated aluminium panel on the inside of the doors that are not going to be operative, in lieu of placing them outside and making a graphic representation of the doors on the panels, doesn't solve the problem of ongoing vandalism and graffiti, but does maintain the doors as being visible, and provides the security and privacy required for the Ink Studio.
